OHIO RIVER BASIN  
COVE RUN, SOMERSET COUNTY  
PENNSYLVANIA  
DEER VALLEY LAKE DAM

NDS I.D. No. PA - 00230  
PENNDER I.D. No. 56 - 76

PHASE I INSPECTION REPORT  
NATIONAL DAM INSPECTION PROGRAM

AUGUST 1979

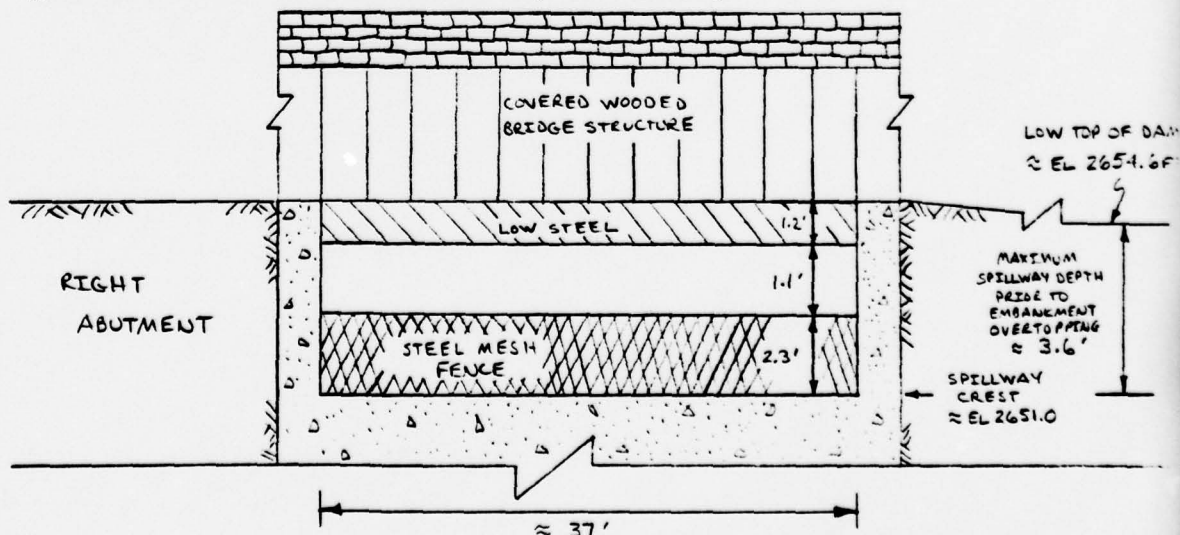
- CROSS-SECTION OF SPILLWAY : (NOT TO SCALE)  
 (BASED ON FIELD MEASUREMENTS AND OBSERVATIONS, AND FIGURE 5)

SECTION TAKEN LOOKING UPSTREAM TOWARD SPILLWAY

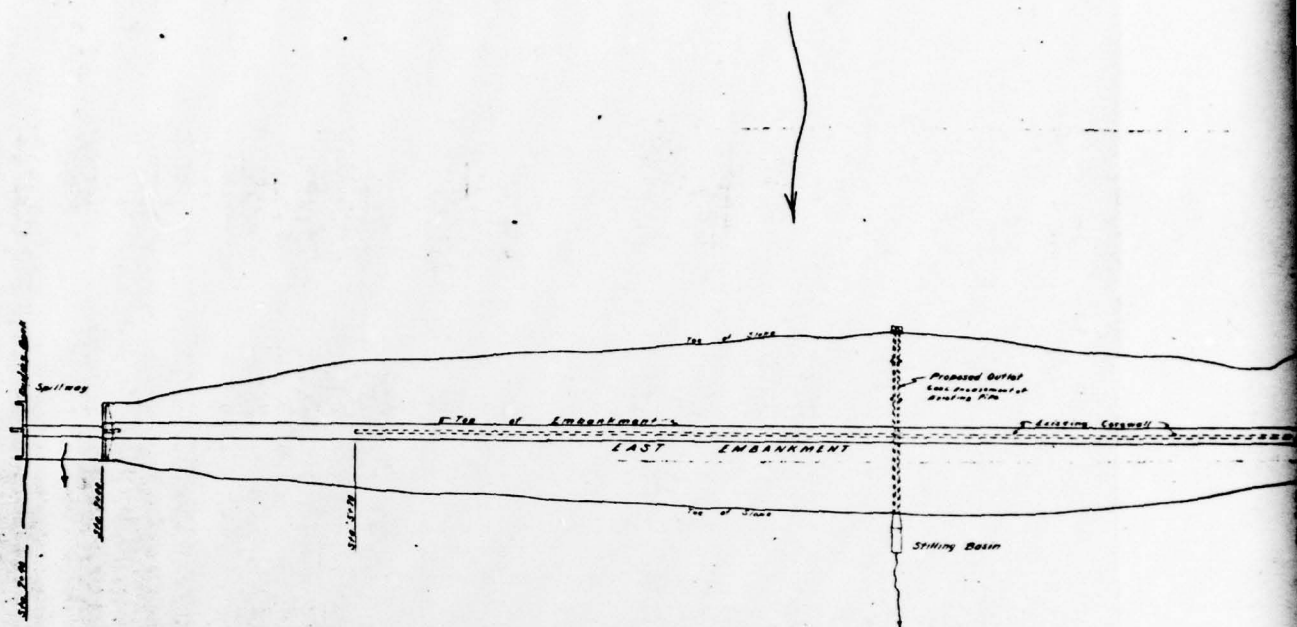
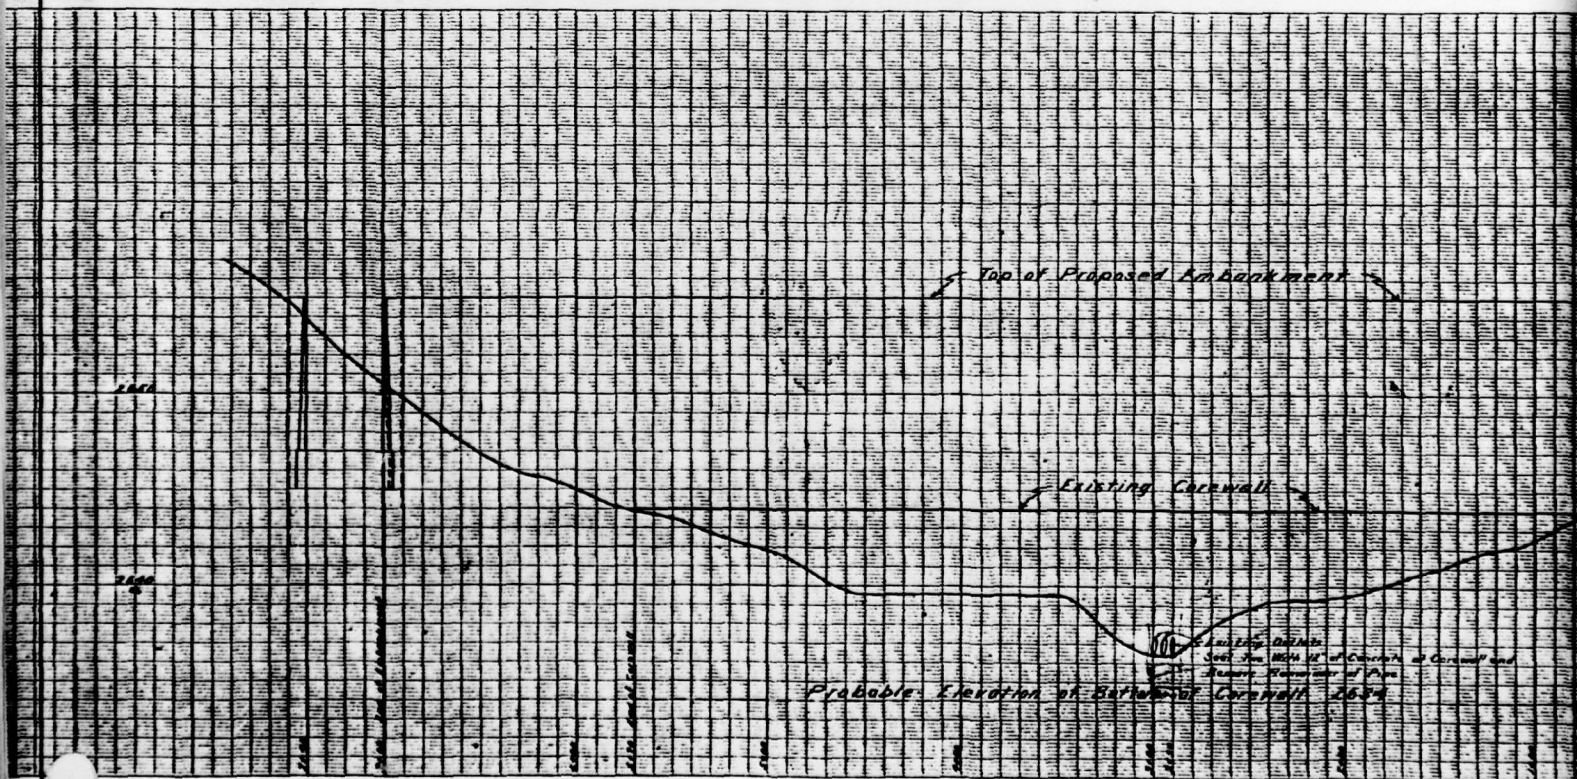
FIGURE 1 - DEER VALLEY LAKE DAM  
GENERAL PLAN : FIELD INSPECTION NOTES

1. Embankment. Details of the design features are based on available correspondence and the field inspection. The actual as-built configuration of the facility is shown on Figure 1 (field sketch). Figures 2 through 5 are design drawings and have not been revised to show as-built conditions.
